Manhole Inspection Summary

Manhole # S47E__005MH

Insp Date: **7/28/08 10:26 AM**

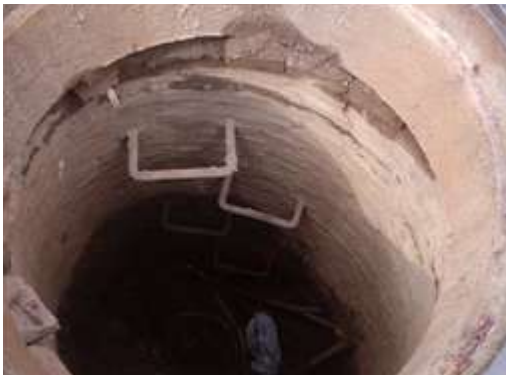
Defect 1

☒ **Leaks**

Frame Leaks

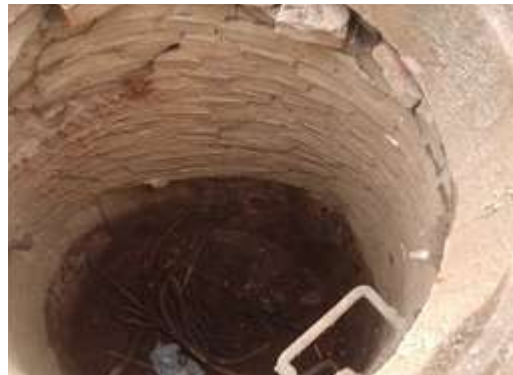
Defect 2

Condition: ☐ Sound ☐ Cracked ☐ Root Intrusion ☒ **Loose Brick** ☐ Deteriorated

Infiltration: ☐ None ☐ Joint ☐ Cracks ☒ **Mortar** ☐ Roots ☐ Wall

Loose Bricks

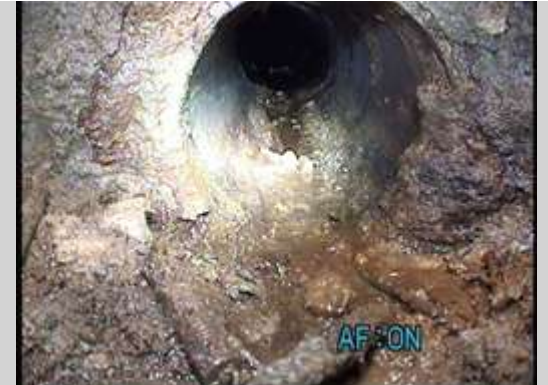
12 O'Clock Outflow

8 in. Circular Gravity Sewer
Pipe Out @ 12 O'Clock

Infiltration: **None** Pipe Seal Cond: **Sound**
